# TEST REPORT

Subject: Vibration test of cabin filter

Ordered by: Nordfil LLC

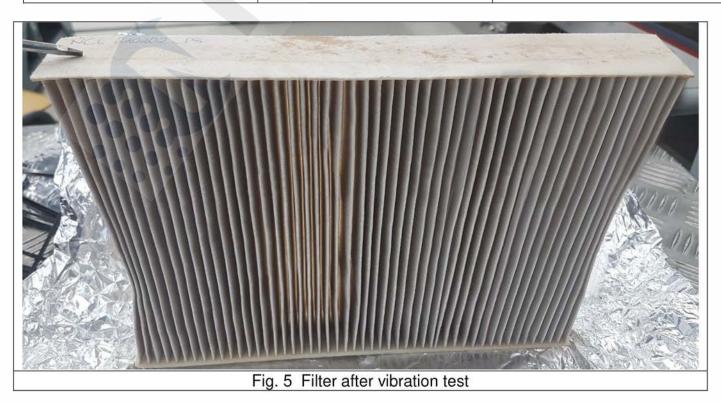
Any visible damage (crack, deformation) wasn't observed after vibration test. The object after vibration test is shown in Fig. 5. Weight of the clogged filter before and after test is shown in table 2.

Ohioat	Weight, g	
Object	Before vibration test	After vibration test
Clogged filter	94,70	94,31
