# TEST REPORT

Subject: Vibration test of cabin filter

Ordered by: Nordfil LLC

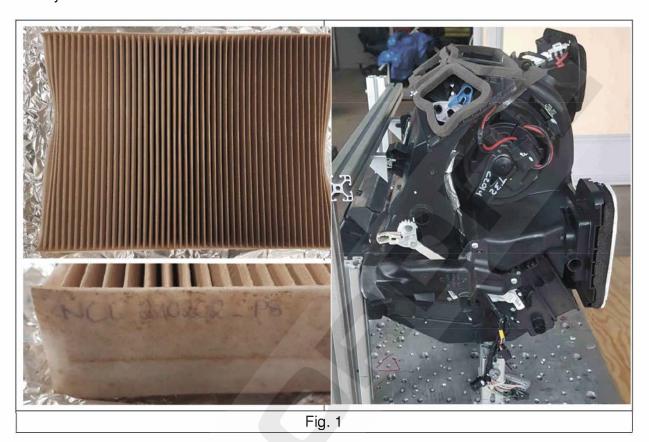
Filter fixed in an HVAC and cabin filter are shown in Fig.1.

Identification: see in Fig. 1
Delivery date: 10.06.2021

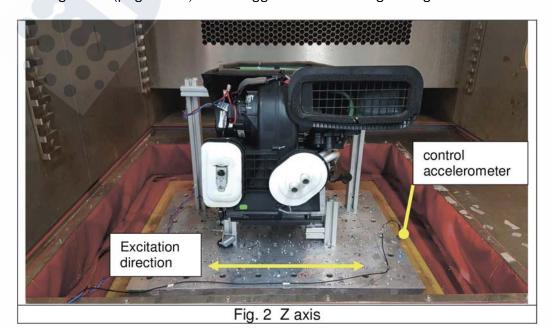
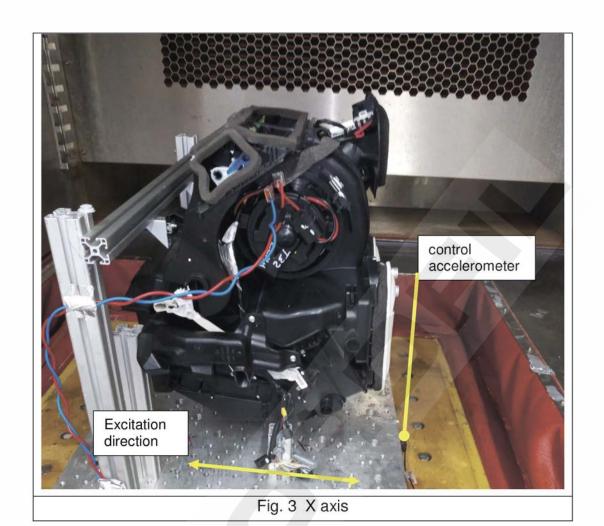
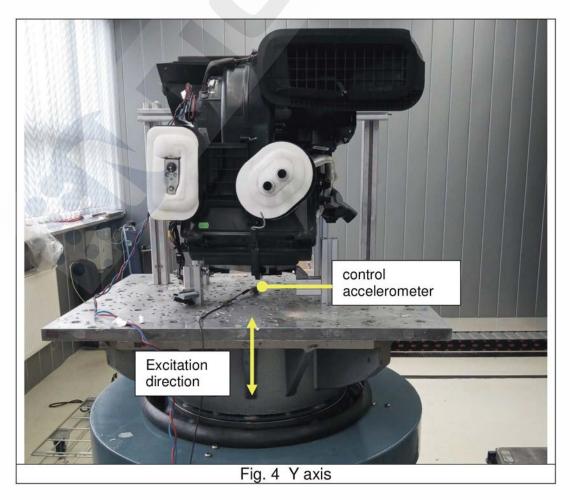
The clogged filter was weighed before it was fixed in an HVAC and mounted on the vibration jig. The vibration test was performed along Z, X and Y axes – sample on vibration stand is presented in Figs. 2..4 (pages 2..3). The clogged filter was weighed again after vibration test.
